Conservation Partners Legacy Grant Program Accomplishment Report

Before machine removal was to occur, a prescribed burn was planned for March 2023 to assist with removing the hybrid cattail old growth. Poor ice conditions and heavy snow did not allow for the planned burn. The aquatic removal process went forward in August, one month later than the expected start date. Due to the County Highway Department's inability to provide their planned in-kind match contribution through completing the biomass hauling (County match funds will now be in the form of actual cash expenses associated with the culvert installation), Lakes Aquatic Weed Removal (LAWR) was contracted to perform cutting, removal, and hauling. This strategy was less effective in terms of the efficiency of the removal and hauling process. LAWR typically does not conduct the hauling portion of cattail removal projects. Therefore, the time for the hauling and staging process was underestimated, exacerbating the already shortened project window before freeze-up.

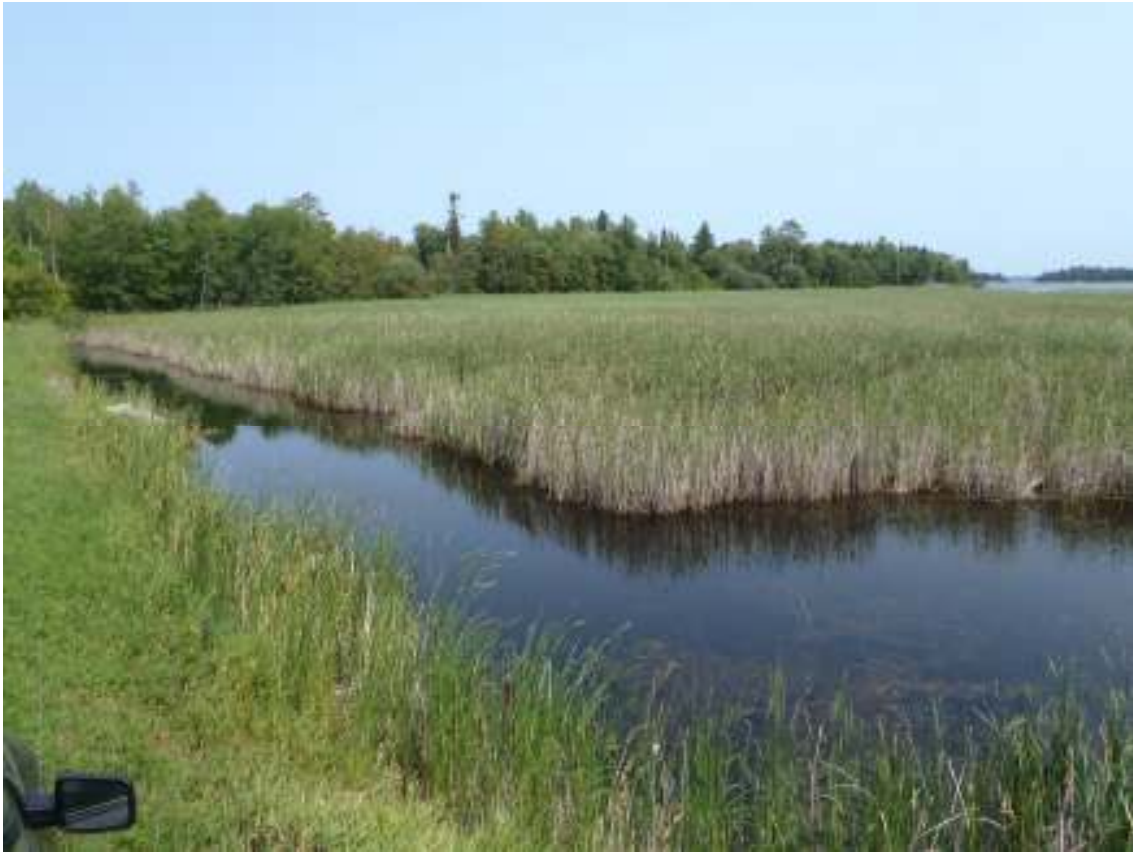
Figure 1 Hybrid cattail mass on east side of CR134. Photo taken before removal on 8/8/2021

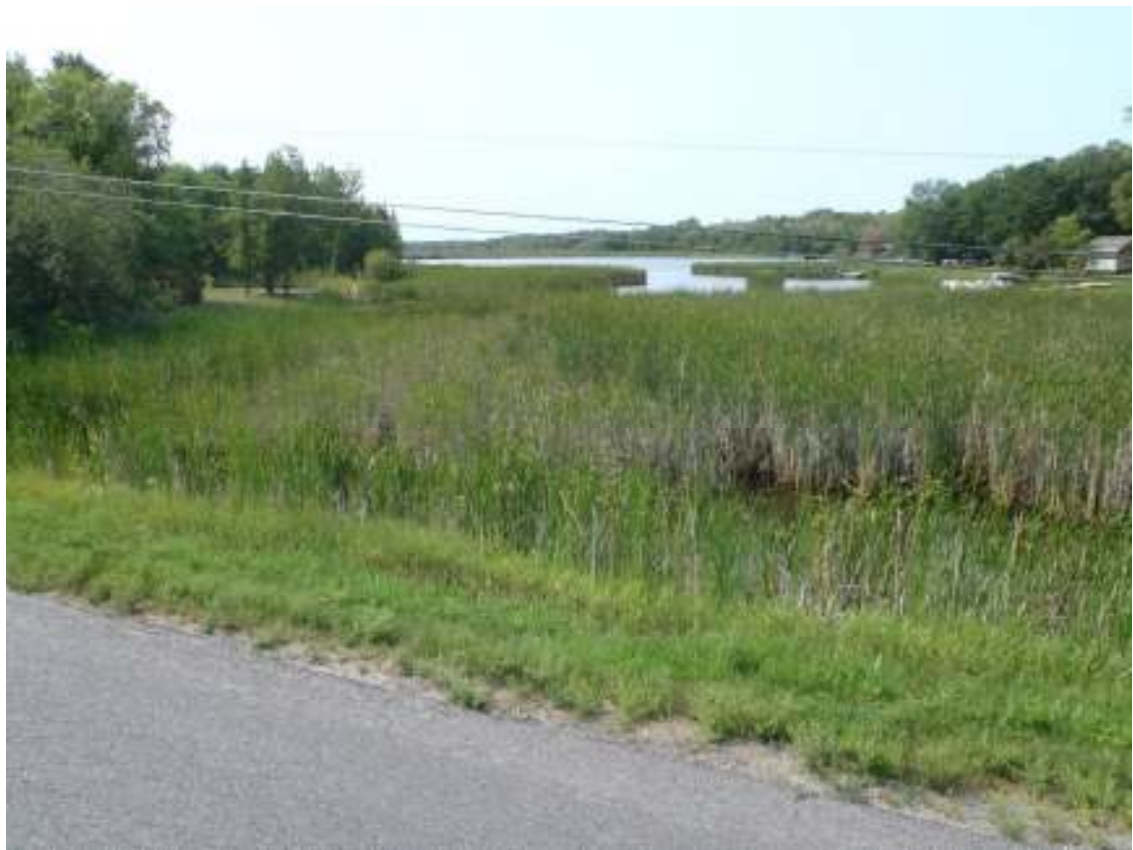
Figure 2 Hybrid cattail mass on west side of CR134. Photo taken on 8/8/2021, before removal.

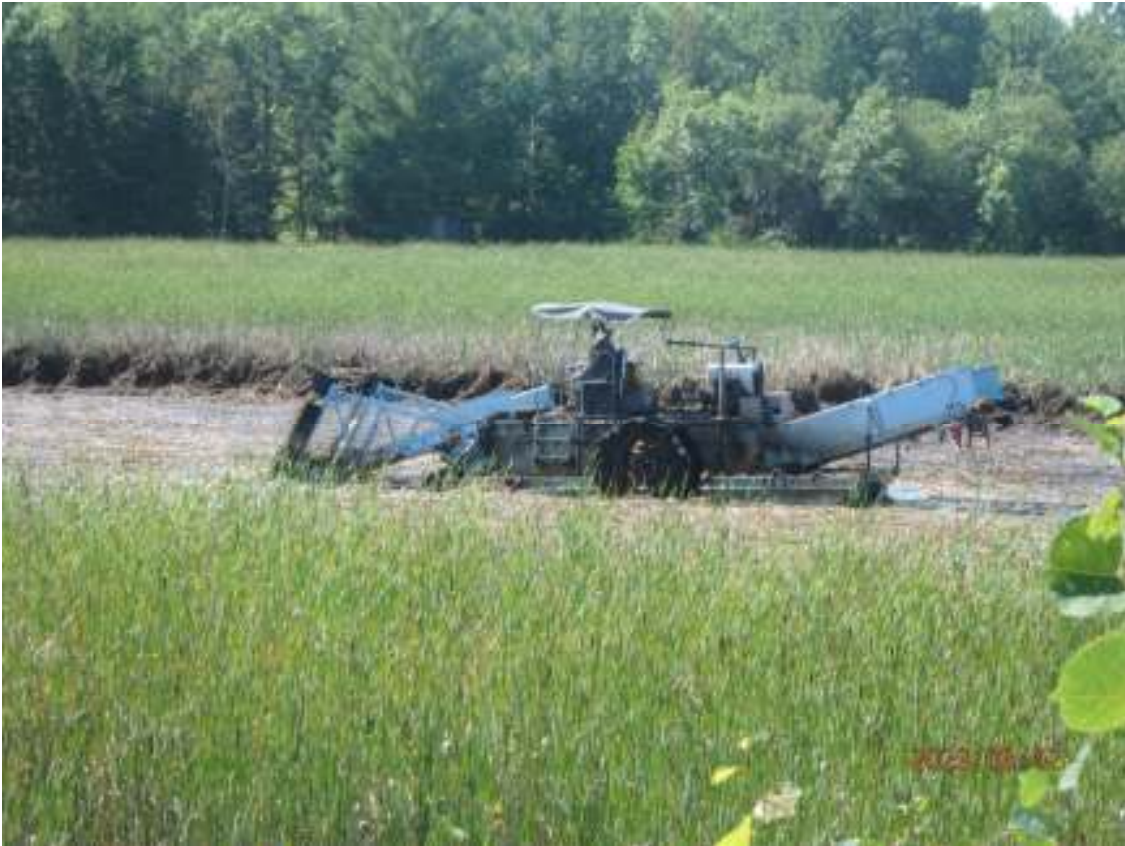
Figure 3 First day of aquatic removal process. Photo taken from the northeast side of the bay, facing south.

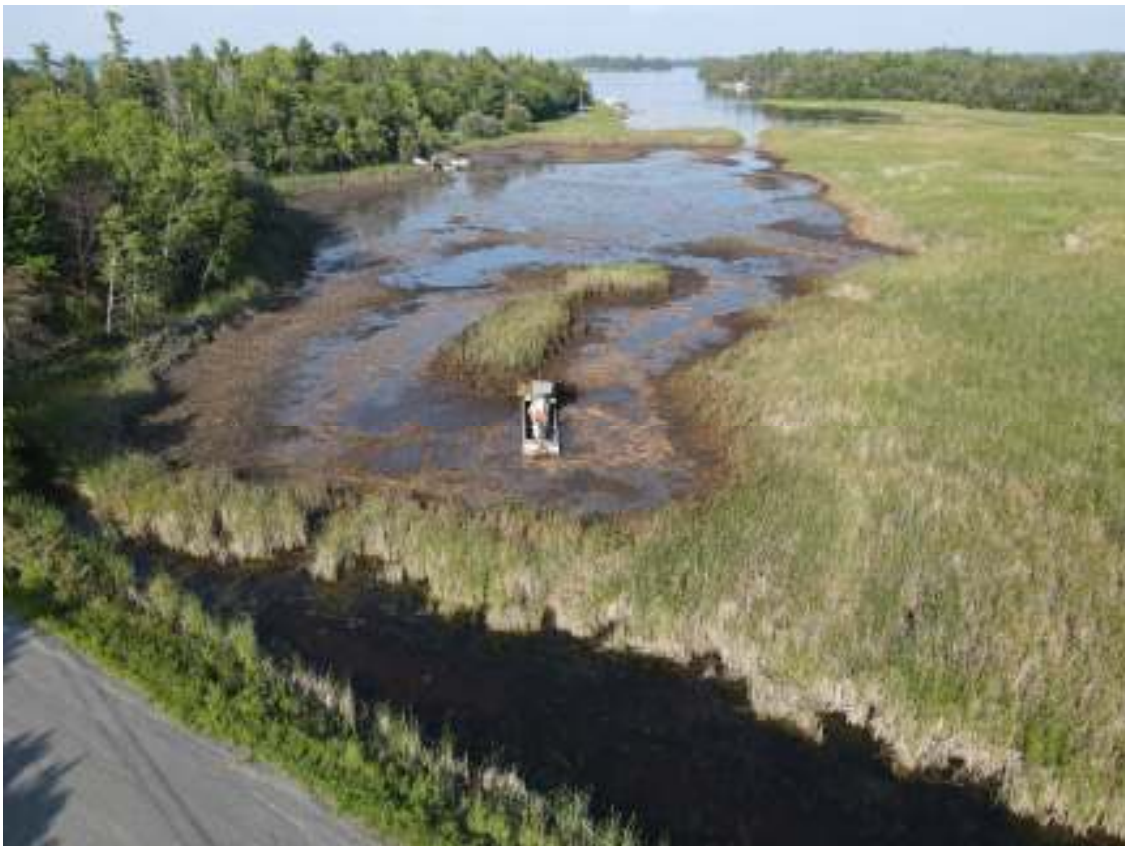
Figure 4 Aerial shot of removal process on the east side of CR134. Photo taken 8/9/2023 by Tom Dougherty

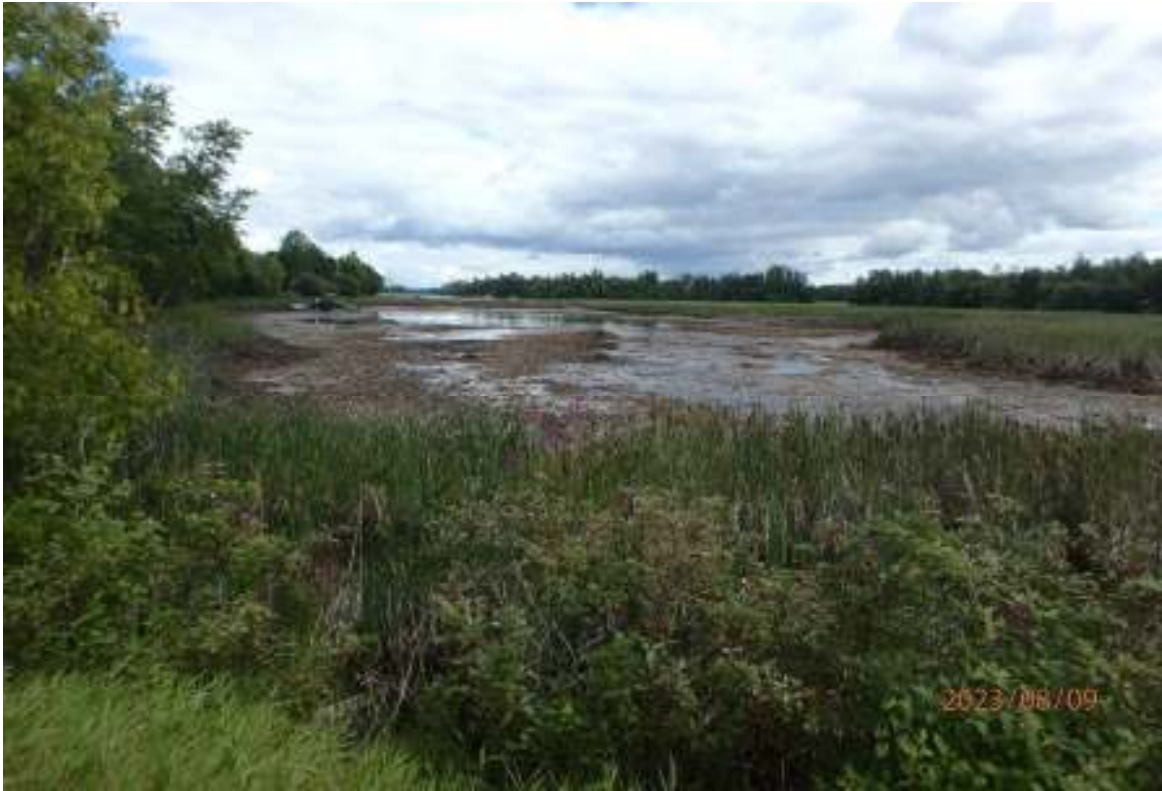
Figure 5 Removal process on the east side of CR134

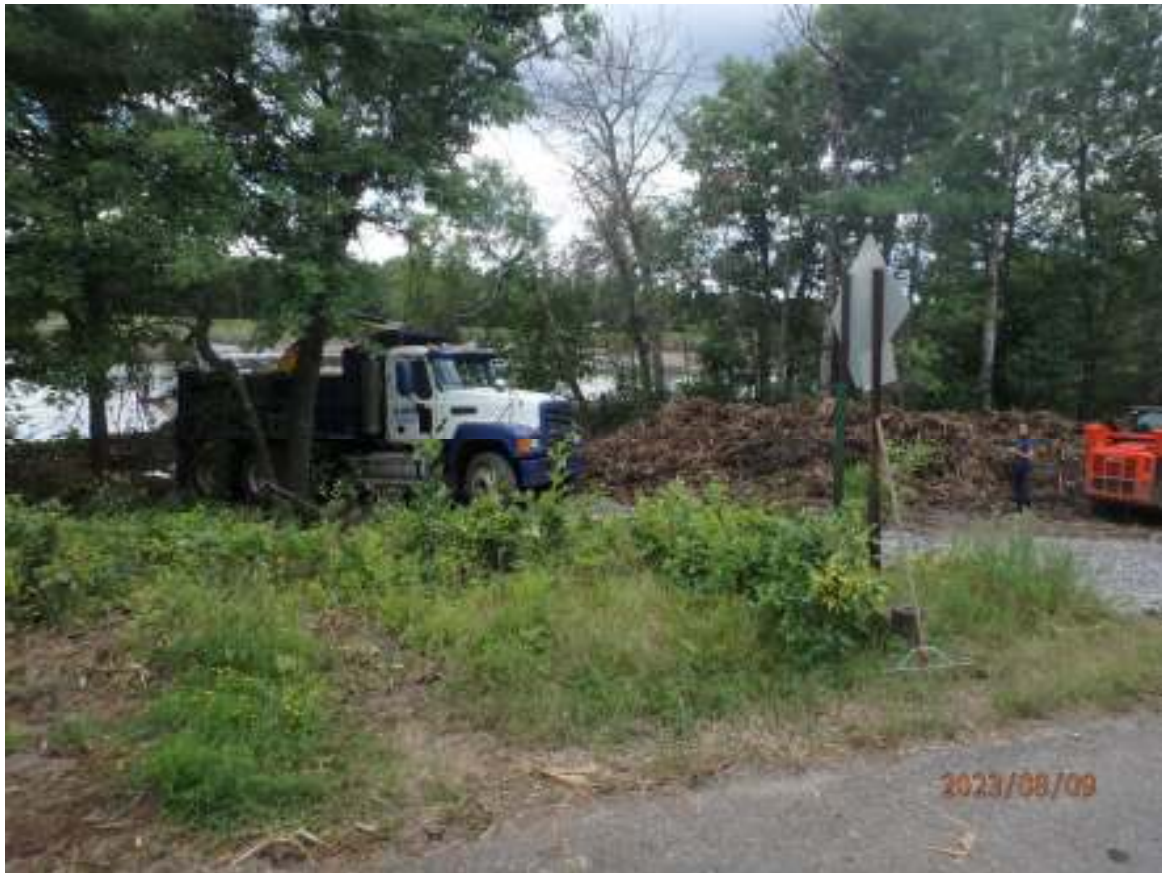
Figure 6 Public access on northeast side of the bay. This access served as the main staging site for removal and piling of biomass

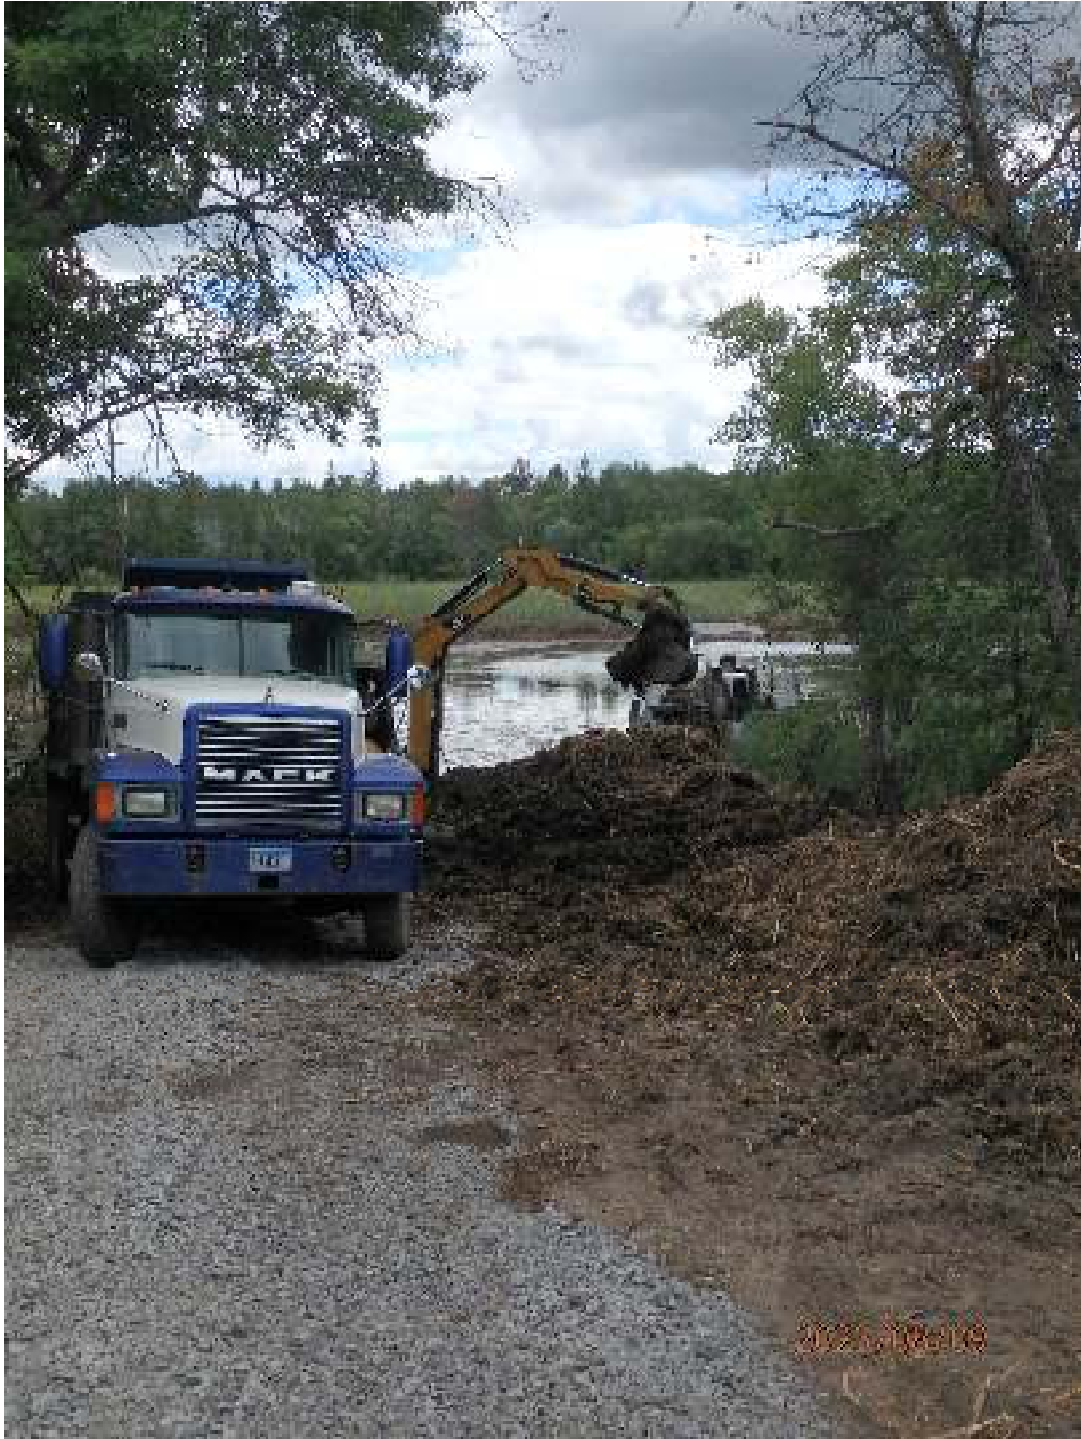
Figure 7 Public access and main staging site for removal and piling of biomass

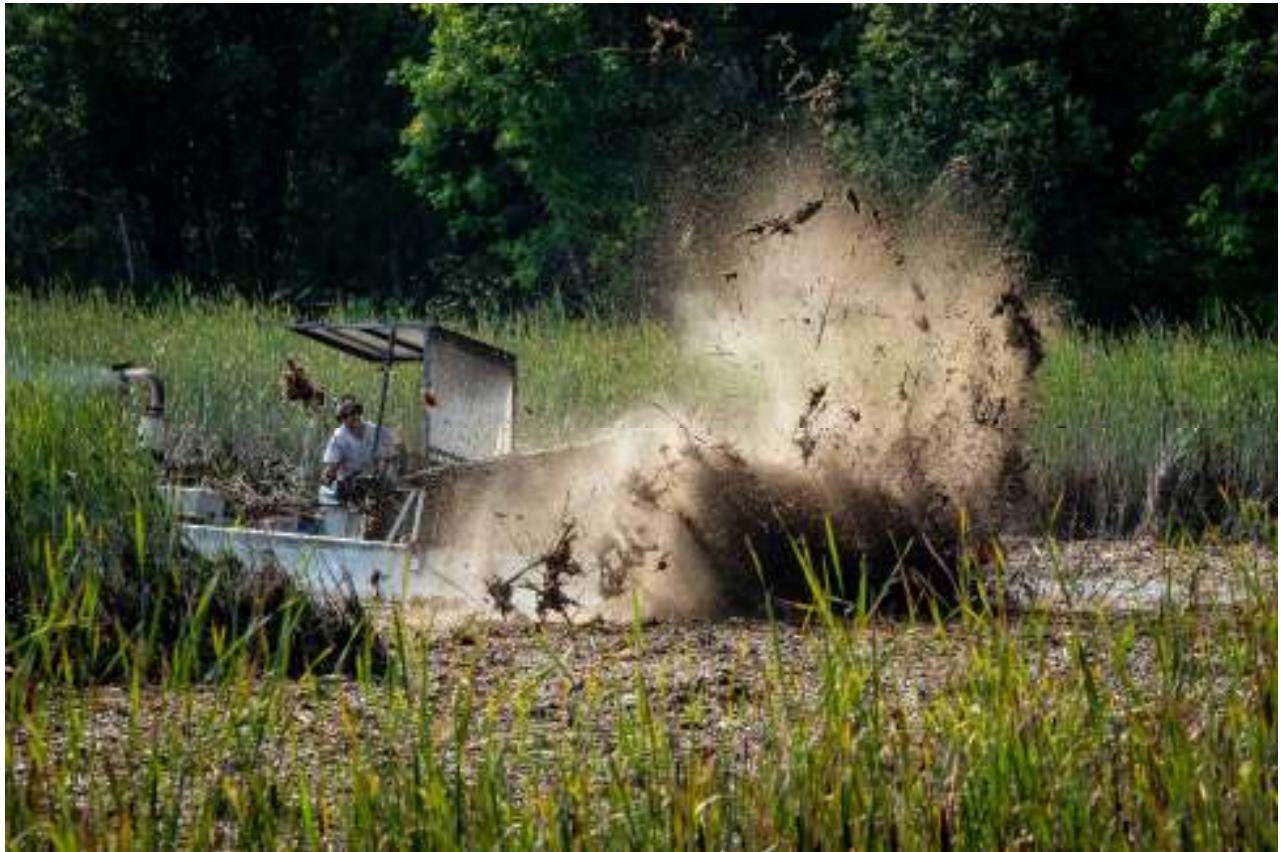
Figure 8 LWR cattail cutting equipment. Photo submitted by Al Meadows on 8/25/2023

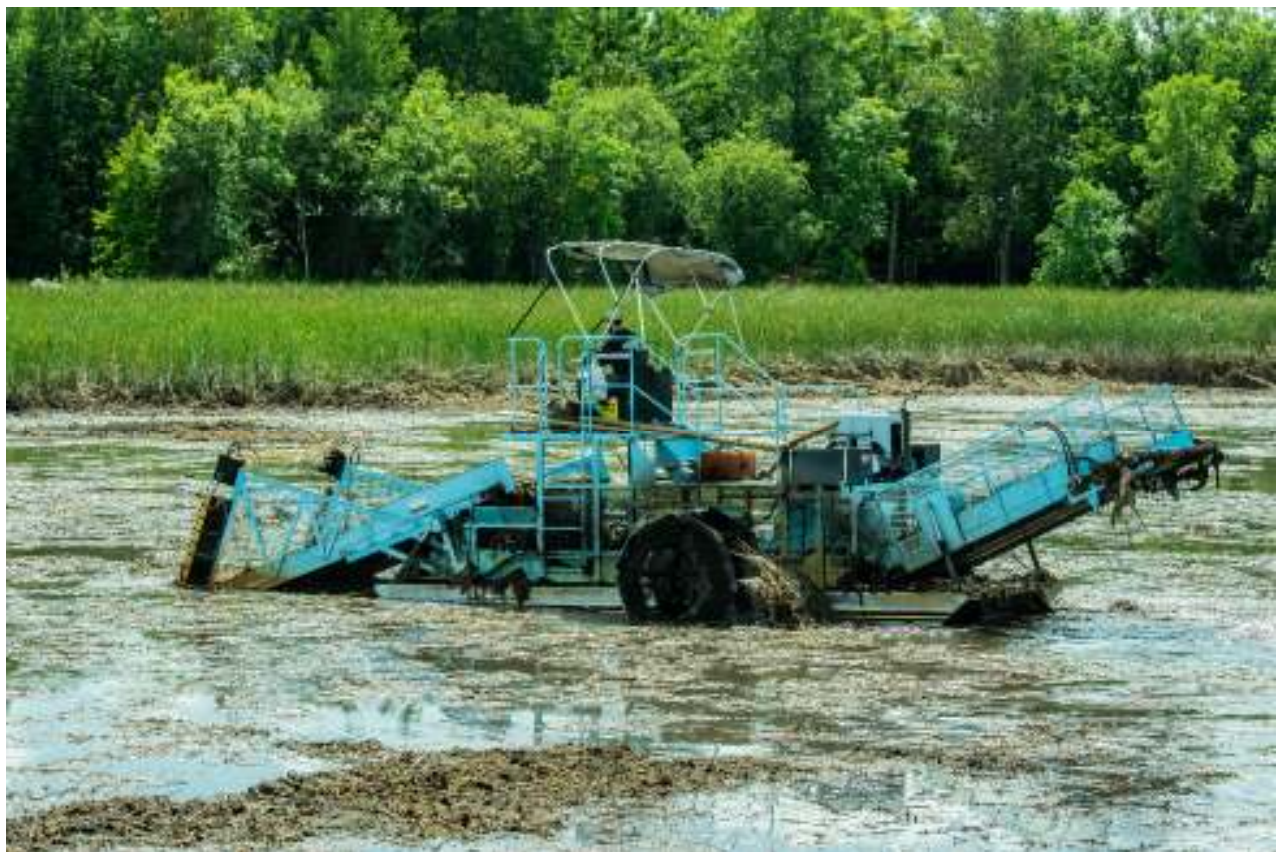
Figure 9 LWR biomass collecting equipment. Photo submitted by Al Meadows on 8/25/2023

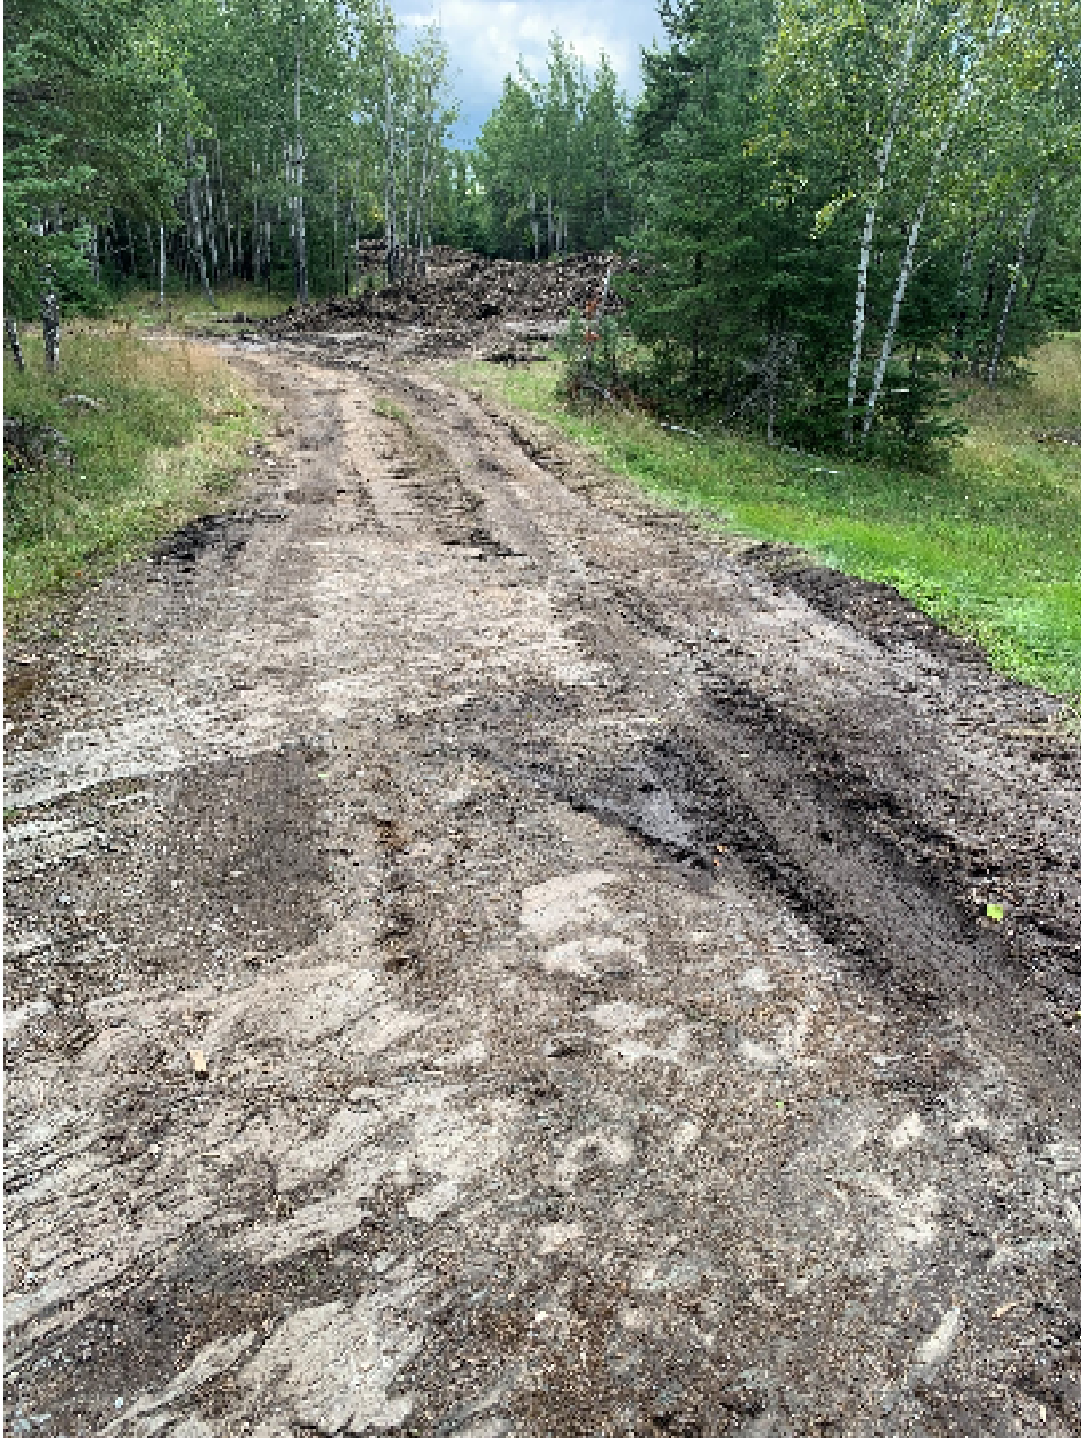
Figure 10 Access road to drop site. Photo taken 8/25/2023

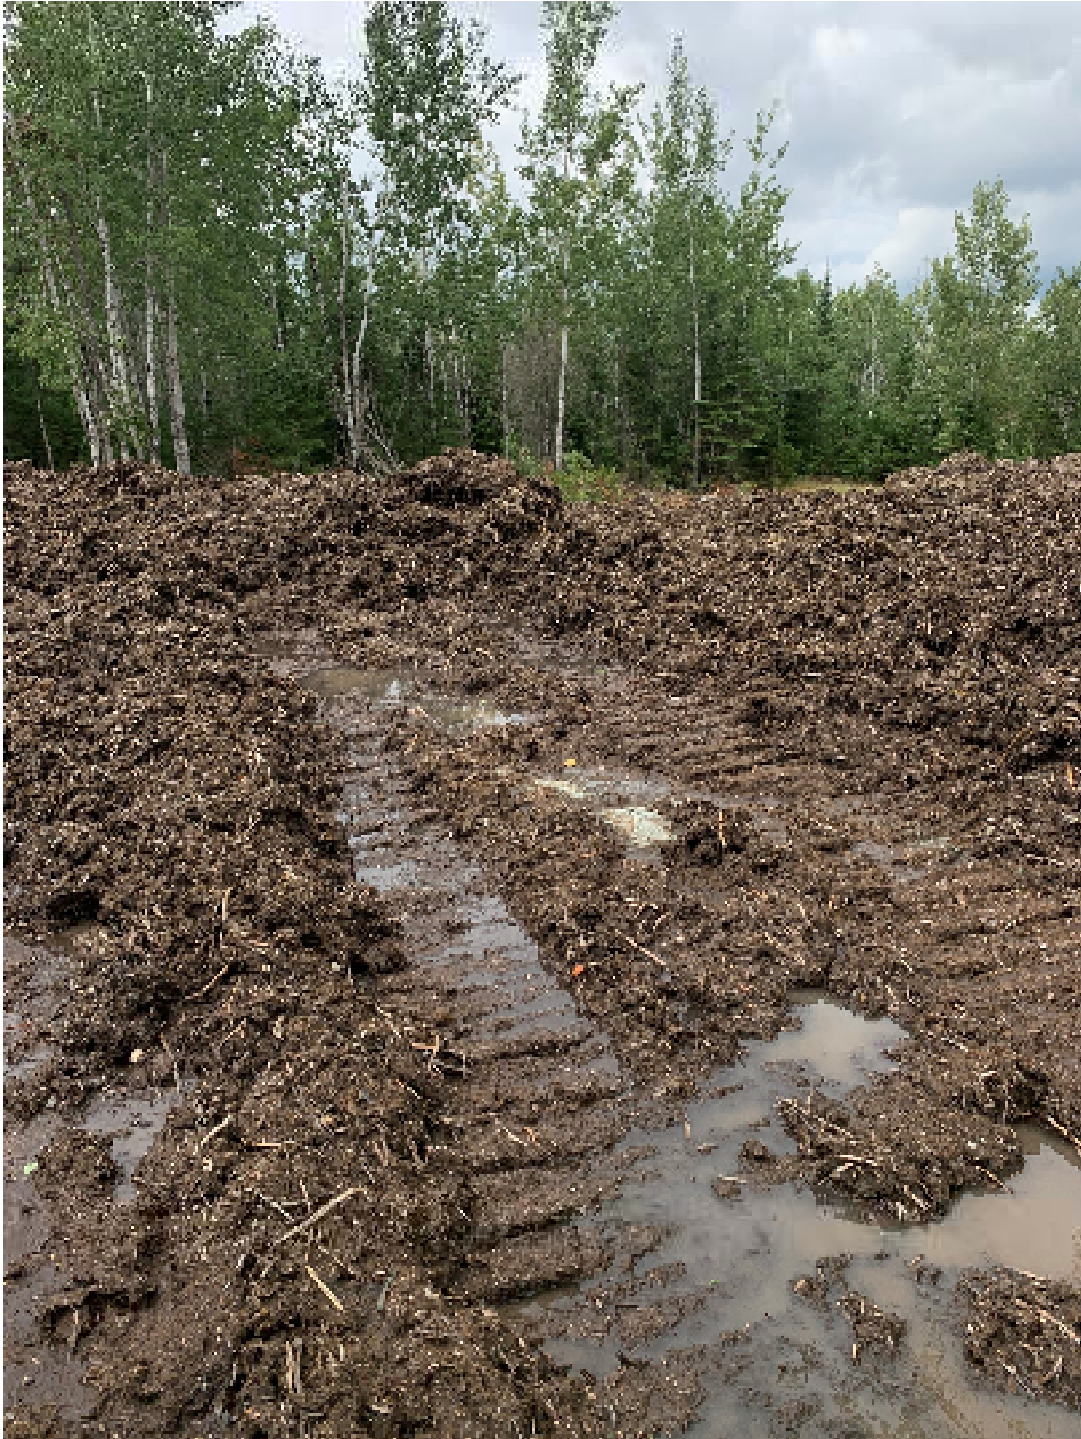
Heavy muck subsurface material made up the bulk of the biomass. LAWR spent 97 hours cutting the biomass and over 670 hours collecting the biomass and disturbed muck that gathered on the water's surface. This biomass consistency made it challenging to work with at the drop site, where the wet material altered site accessibility and dozer equipment capacity. To manage these challenges, the biomass required three days of partial draining at the removal site before hauling. Although necessary, this resulted in accumulation and crowding at the work areas. LAWR handled the biomass 2-5 times for this draining and hauling process. Additionally, it became necessary to coordinate an alternative drop site due to landowner coordination issues. Access to the new drop site was dependent on ideal weather conditions. These challenges added significant contractor hours and extended the project timeline for this portion of the project. LAWR's contract required an extension to continue the removal and hauling process.

Figure 11 South side of biomass drop location. Photo taken 8/25/2023

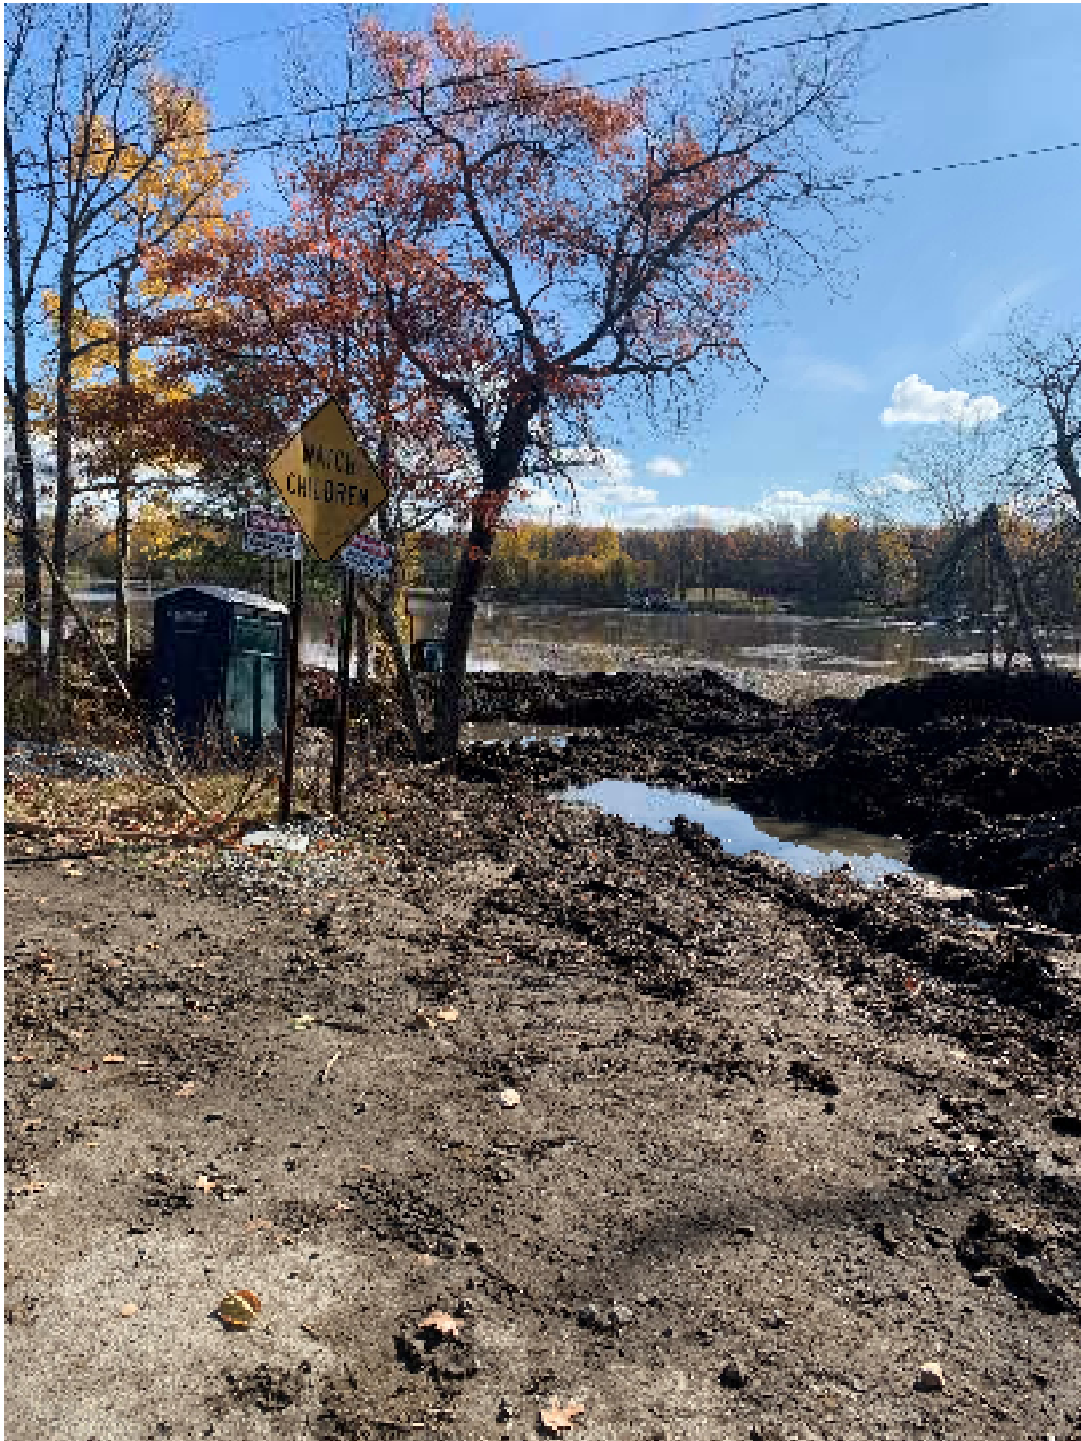
Figure 12 Public access and main staging site for removal and piling of biomass. Photo taken 10/19/2023

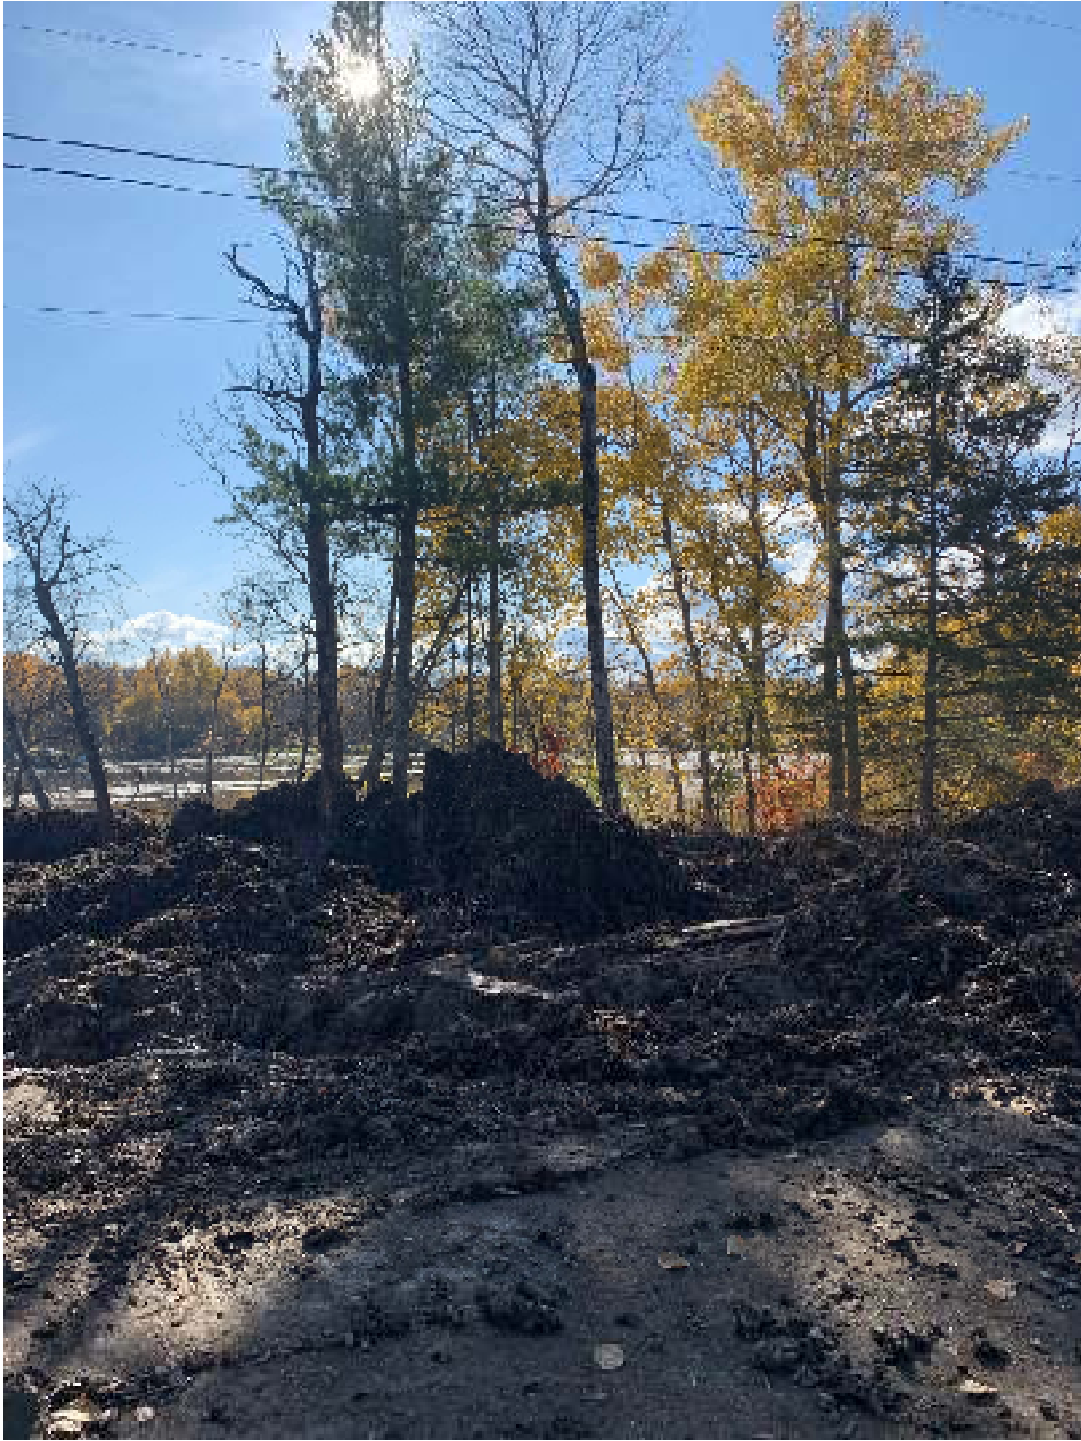
Figure 13 Piles of biomass at the public access. Photo taken 10/19/2023

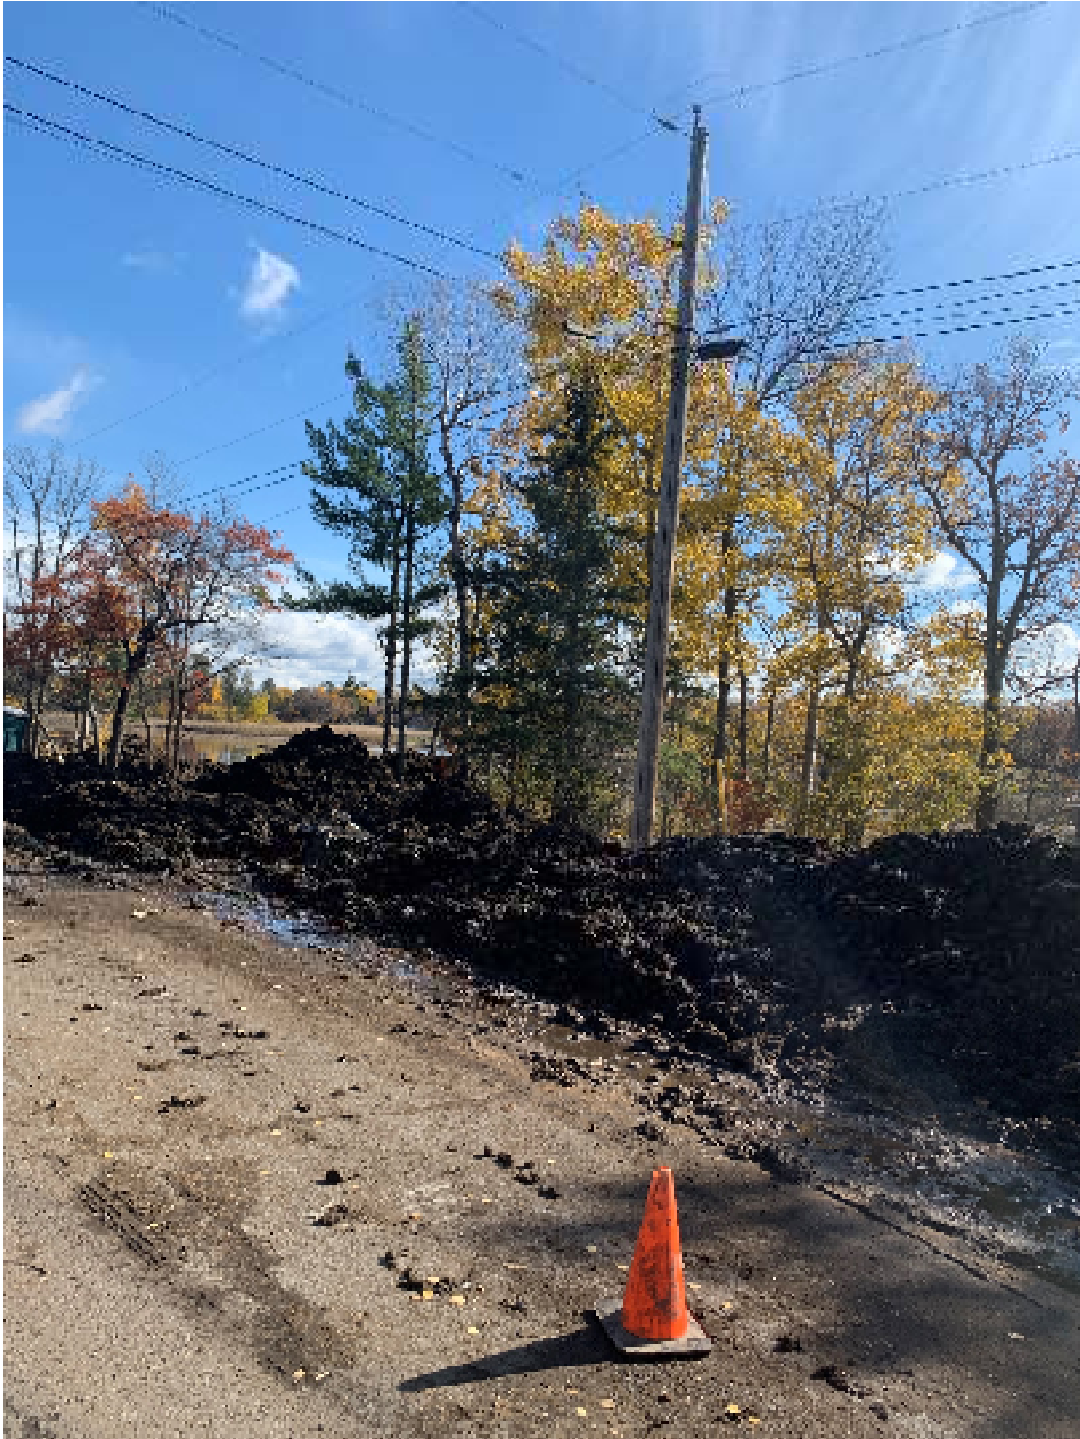
Figure 14 Piles of biomass at the public access.

Photo taken on 10/19/2023 - 30 yards west of the public access, facing east towards the access

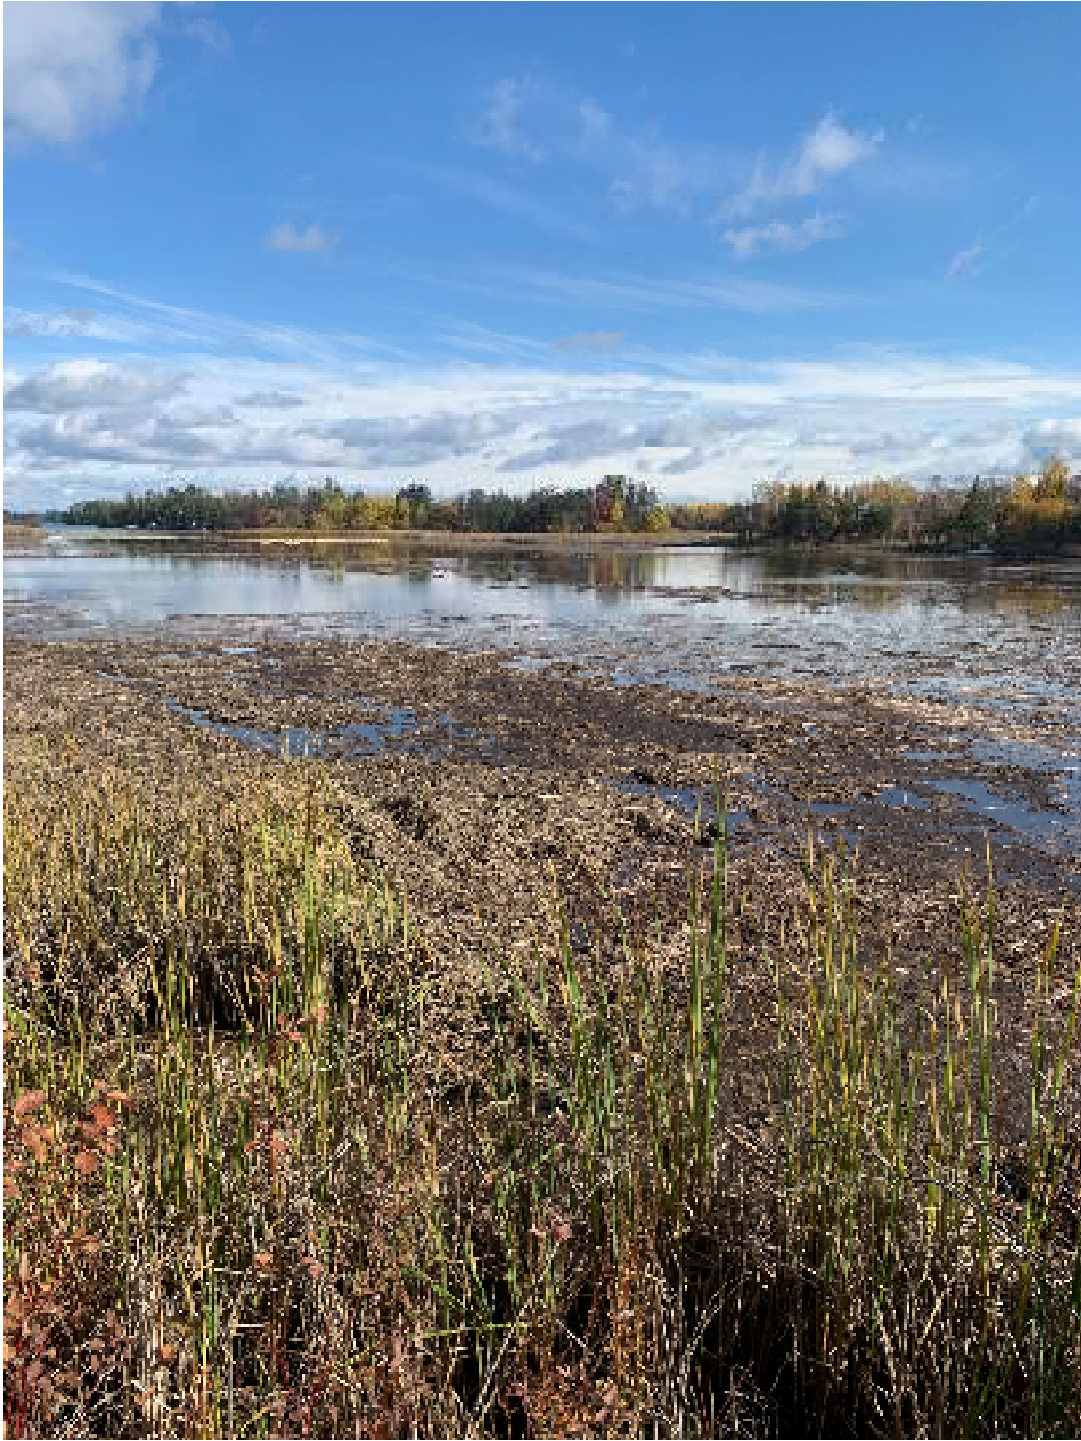
Figure 15 Removal progress on east side of CR134. Photo taken 10/19/2023

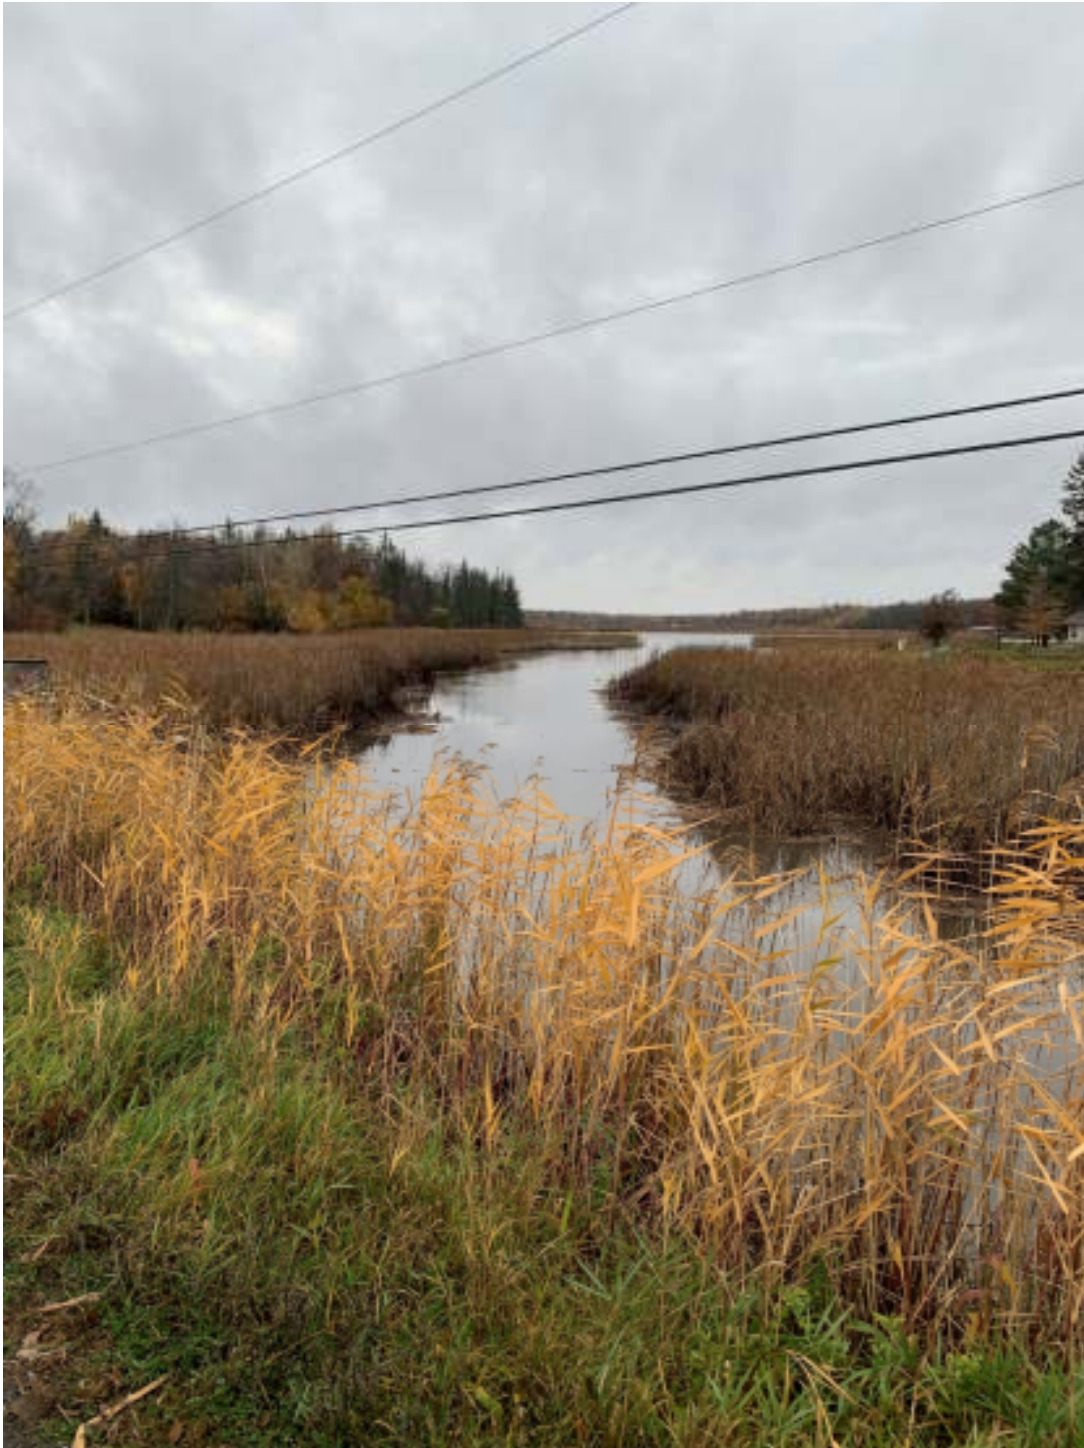
Figure 16 Temporary solution - 16ft channel cut through for additional water flow to the culvert on the western portion of the restoration site.

Photo taken 10/23/2023 from CR 134 culvert facing west.

As work continued through the end of October, the threat of freezing conditions at the removal site became a concern. Kennedy Trucking was contracted to assist with hauling biomass to the County Transfer station. Lacking the time and weather conditions to complete the west portion, LAWR removed a 16ft wide channel through the hybrid cattails on west side of County Road 134 as a temporary solution to assist with water flow through the existing culvert.

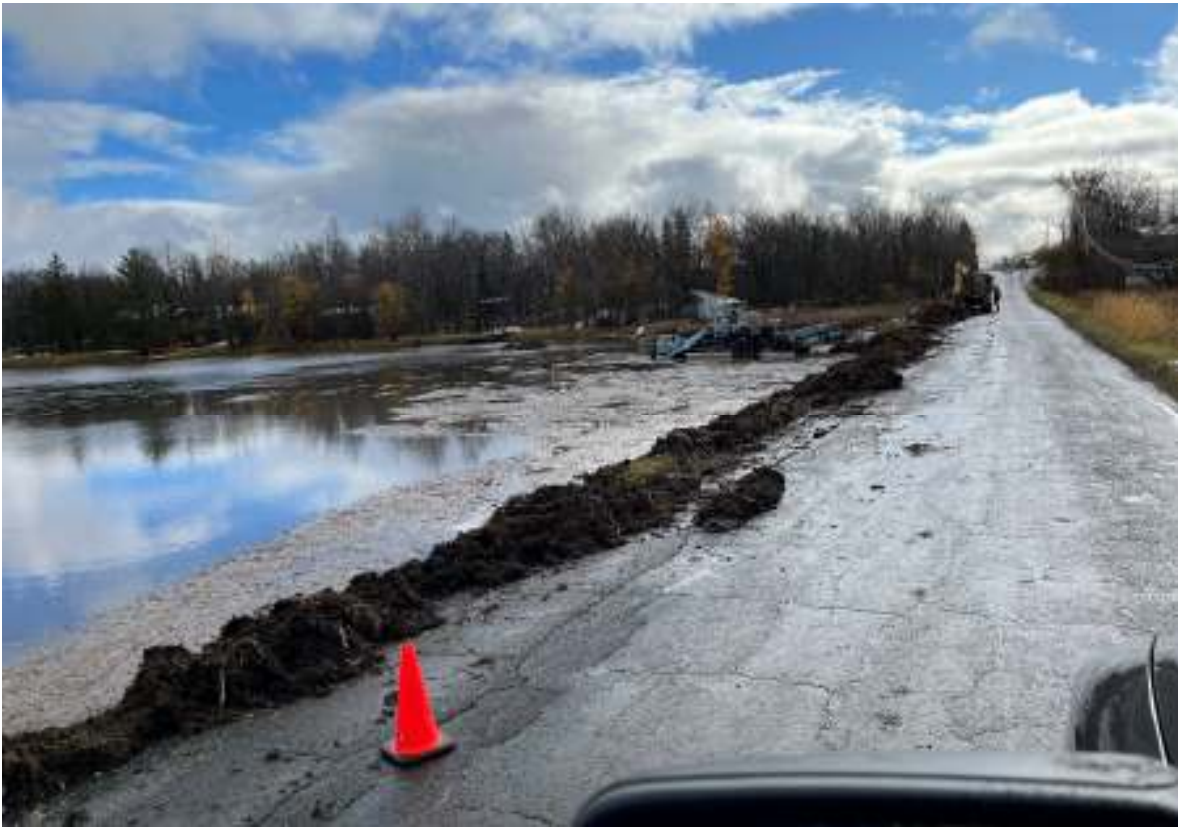
Figure 17 Removal and piling of biomass along CR134. Photo taken on 10/26/2023 - on CR134 facing south.
