Conservation Partners Legacy Grant Program Accomplishment Report

Before machine removal was to occur, a prescribed burn was planned for March 2023 to assist with removing the hybrid cattail old growth. Poor ice conditions and heavy snow did not allow for the planned burn. The aquatic removal process went forward in August, one month later than the expected start date. Due to the County Highway Department's inability to provide their planned in-kind match contribution through completing the biomass hauling (County match funds will now be in the form of actual cash expenses associated with the culvert installation), Lakes Aquatic Weed Removal (LAWR) was contracted to perform cutting, removal, and hauling. This strategy was less effective in terms of the efficiency of the removal and hauling process. LAWR typically does not conduct the hauling portion of cattail removal projects. Therefore, the time for the hauling and staging process was underestimated, exacerbating the already shortened project window before freeze-up.

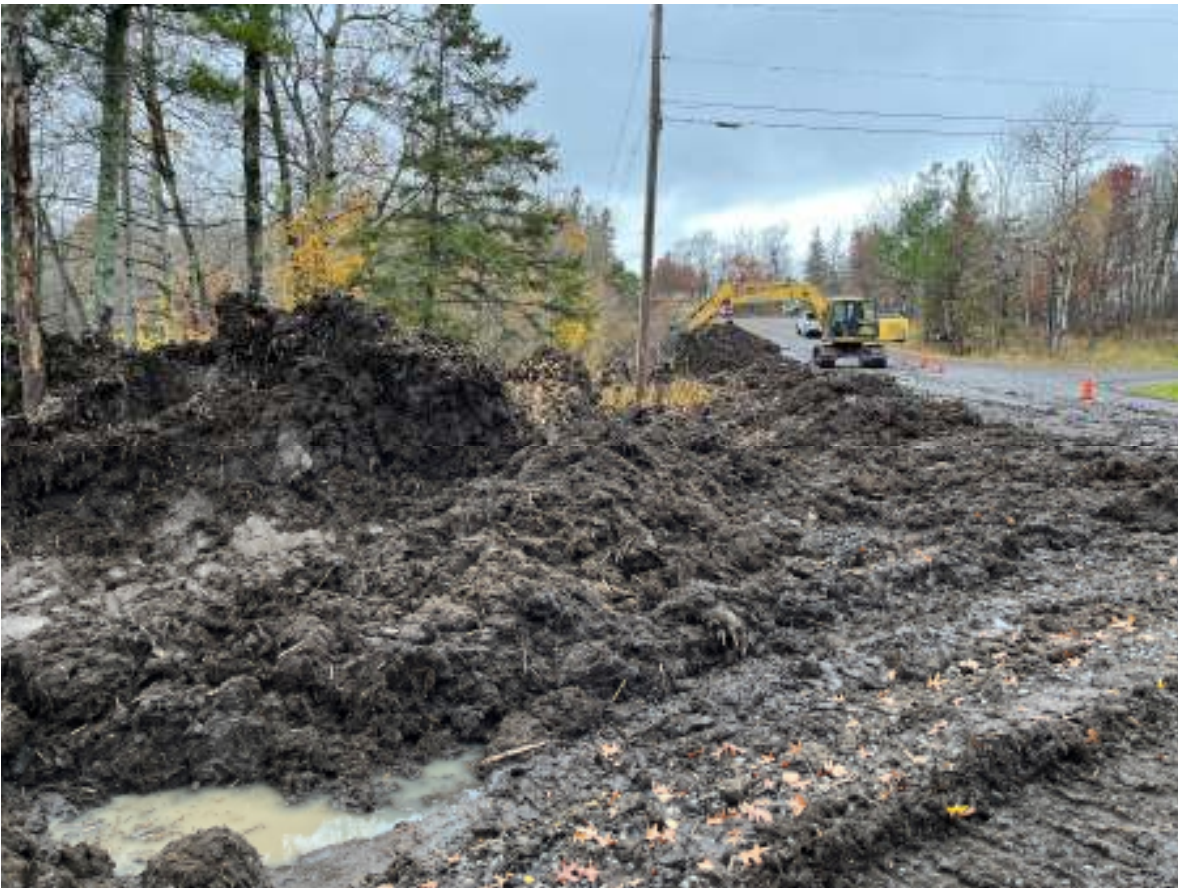
Figure 18 Biomass piled at the public access. Photo taken on 10/24/2023 – from public access facing west

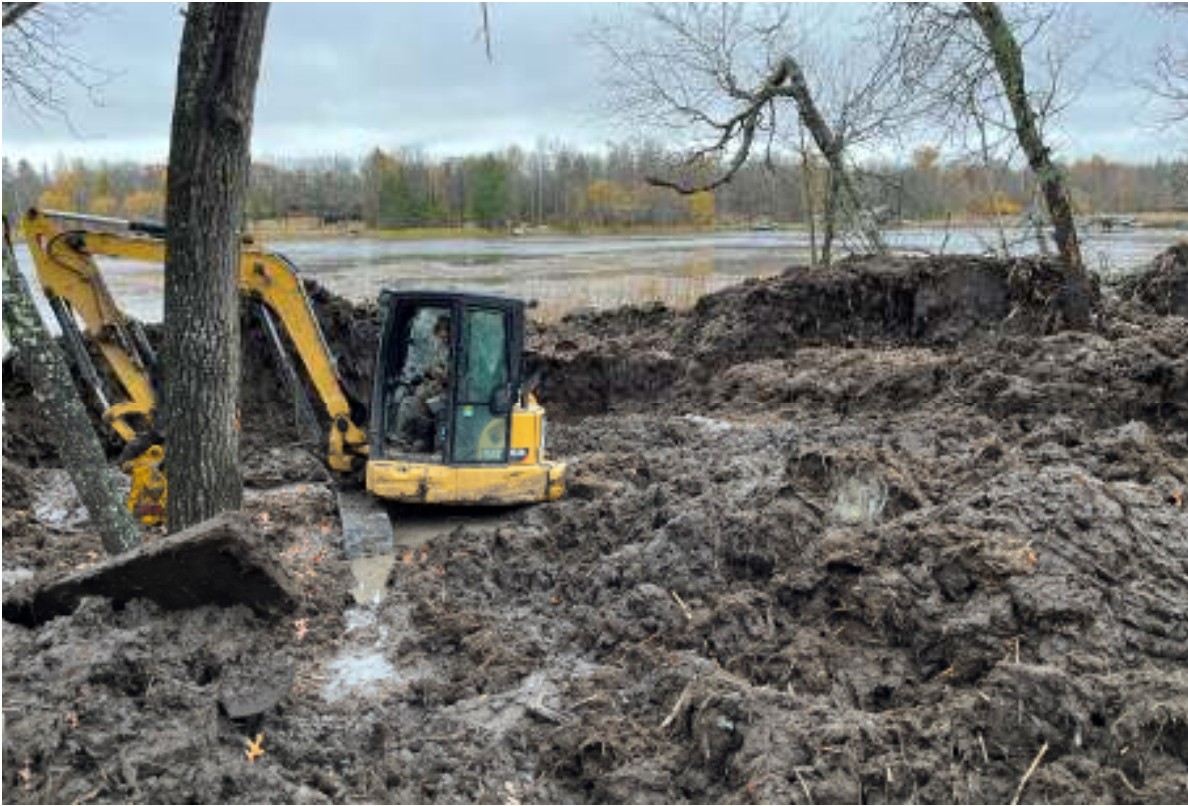
Figure 19 Biomass piled at the public access. Photo taken on 10/24/2023.

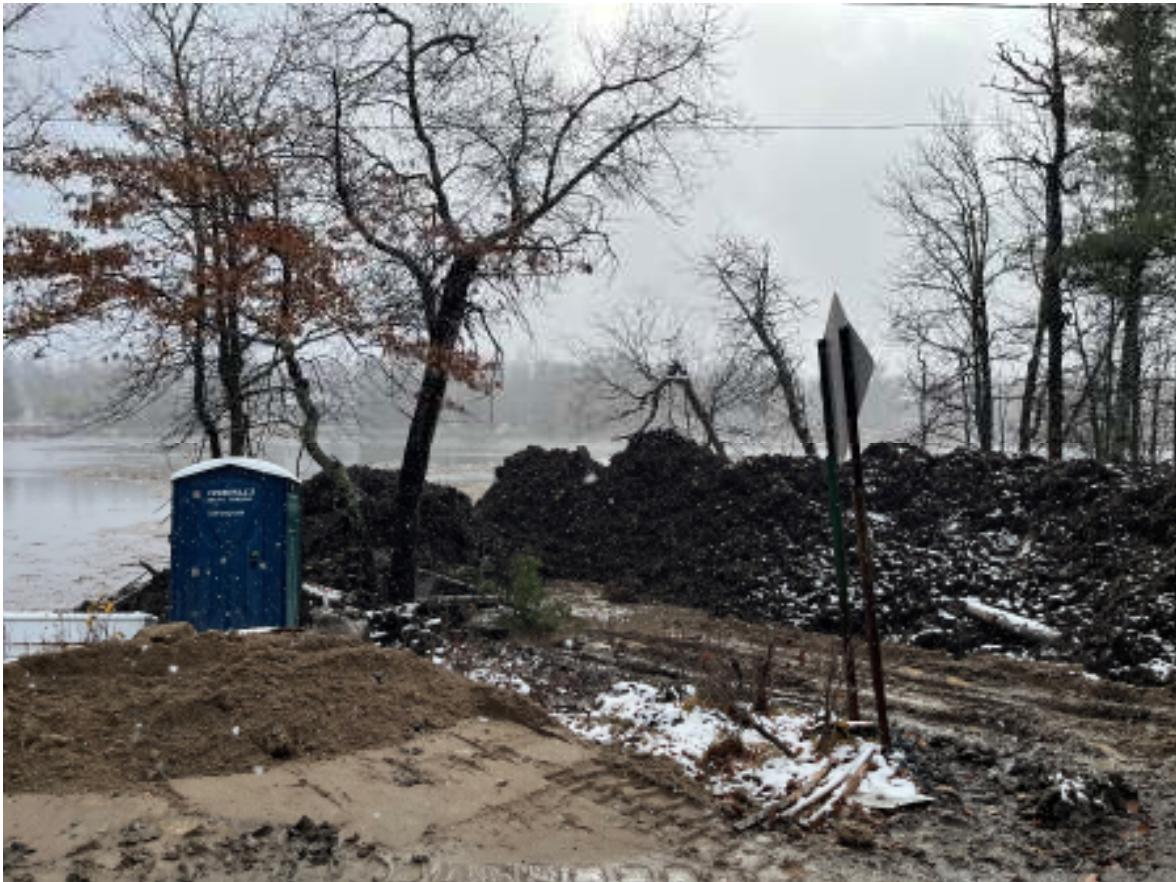
Figure 20 Biomass piled at public access. Photo taken on 10/26/2023

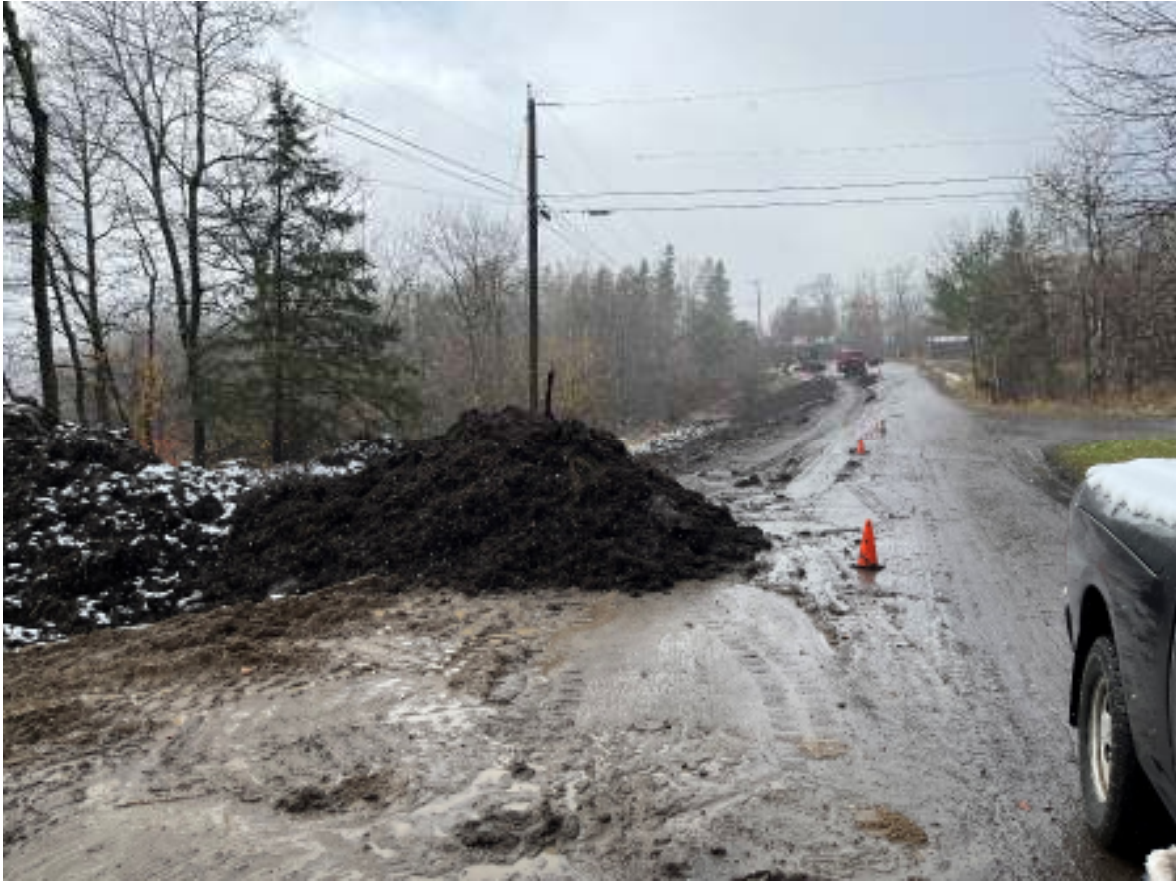
Figure 21 Biomass piled at public access. Photo taken 10/26/2023 - facing west from access

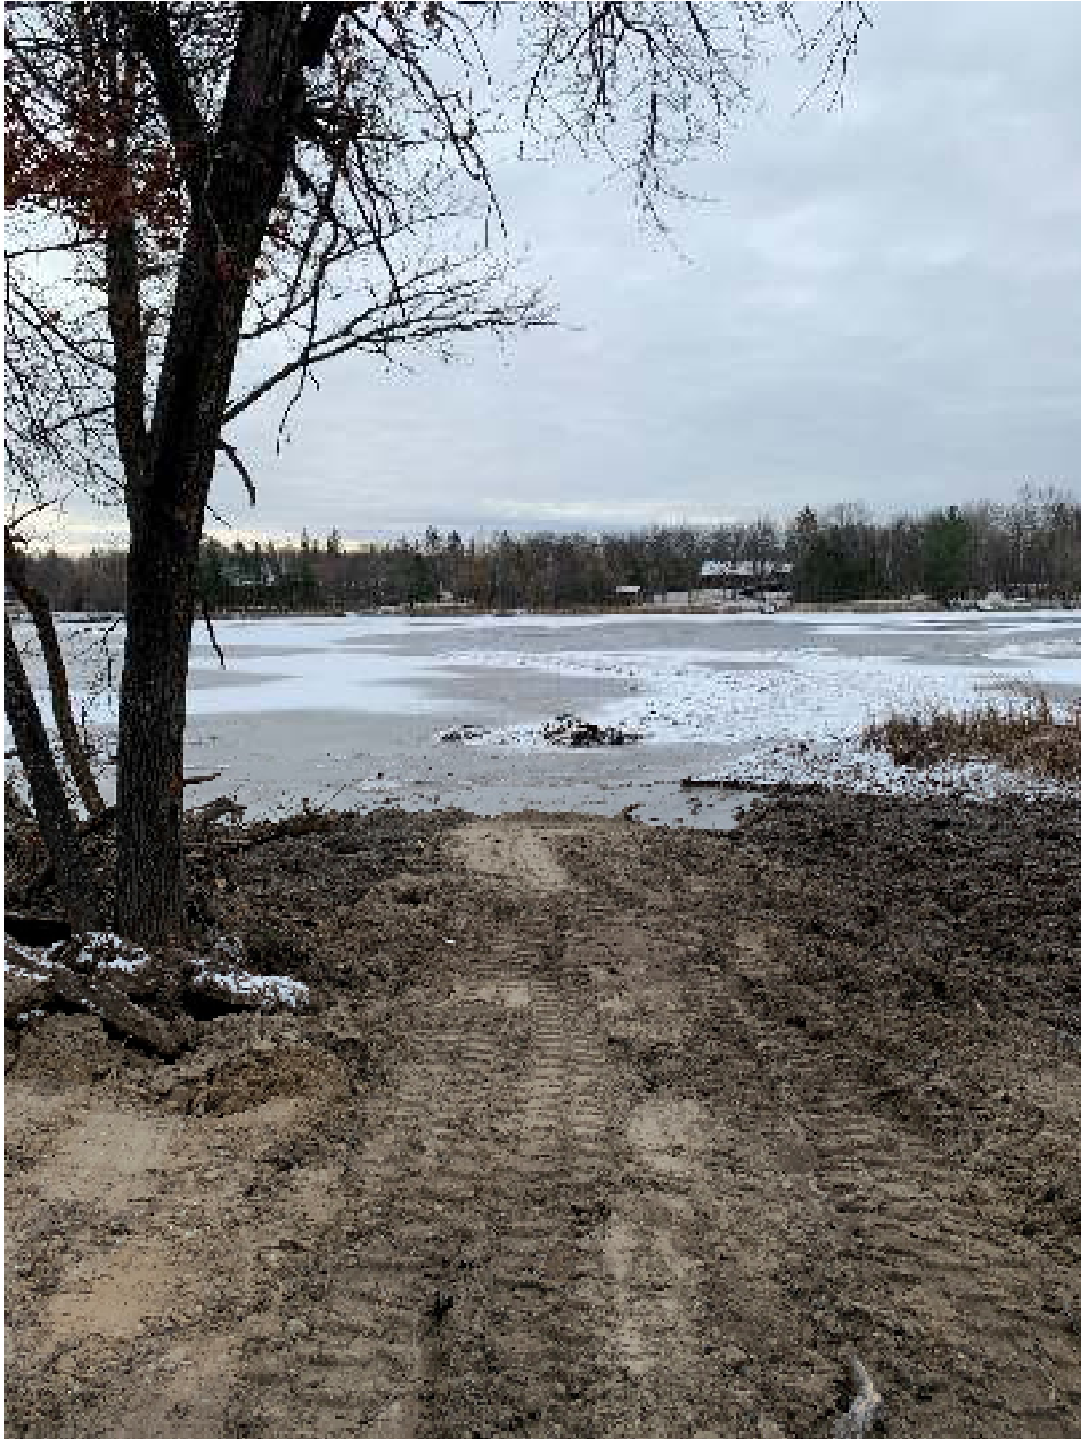
Figure 22 Clean up at the public access. Photo taken 11/1/2023 from top of access facing south.

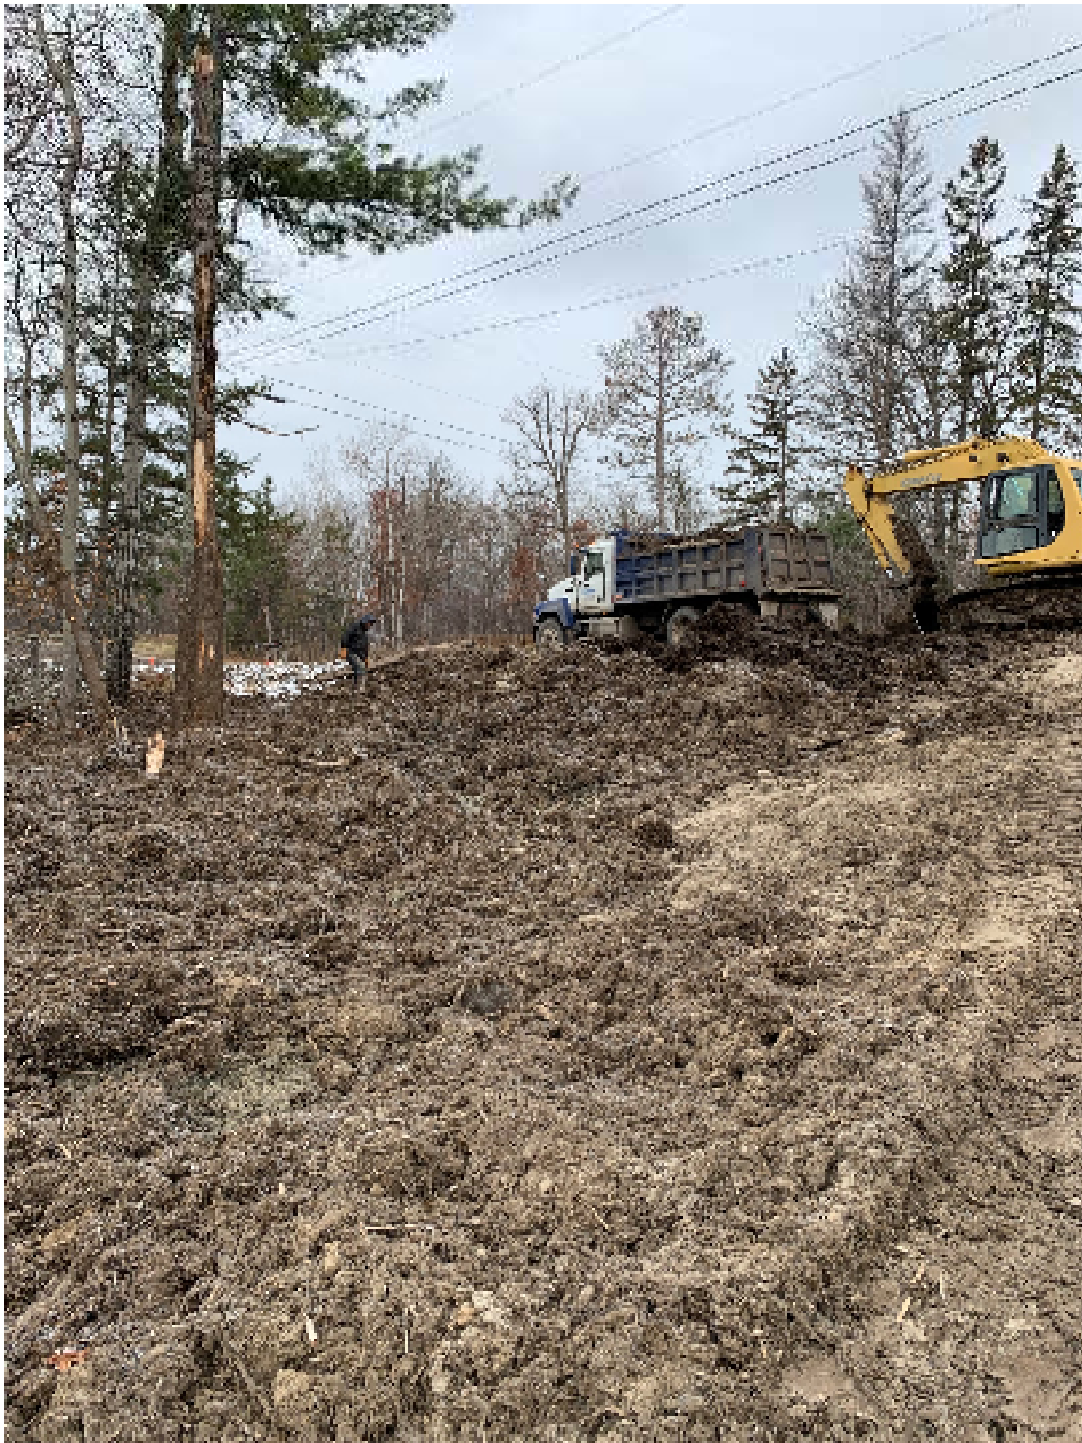
Figure 23 Clean up at public access. Photo take 11/1/2023 from bottom of access facing northwest.

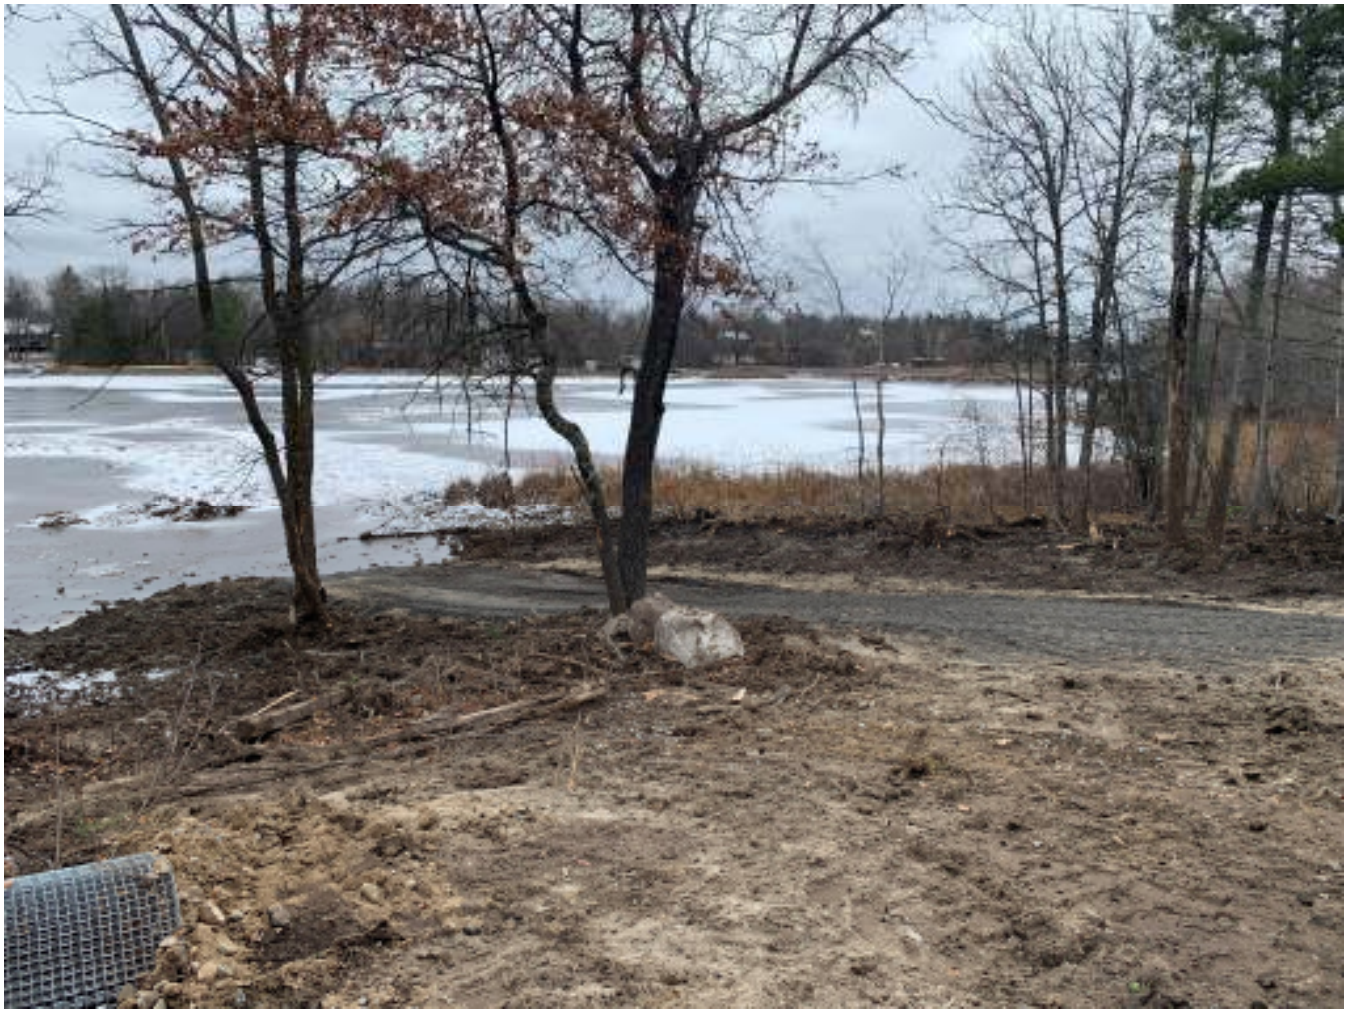
Figure 24 Resurfaced public access. Photo taken 11/2/2023 facing southwest across public access and east restoration area.

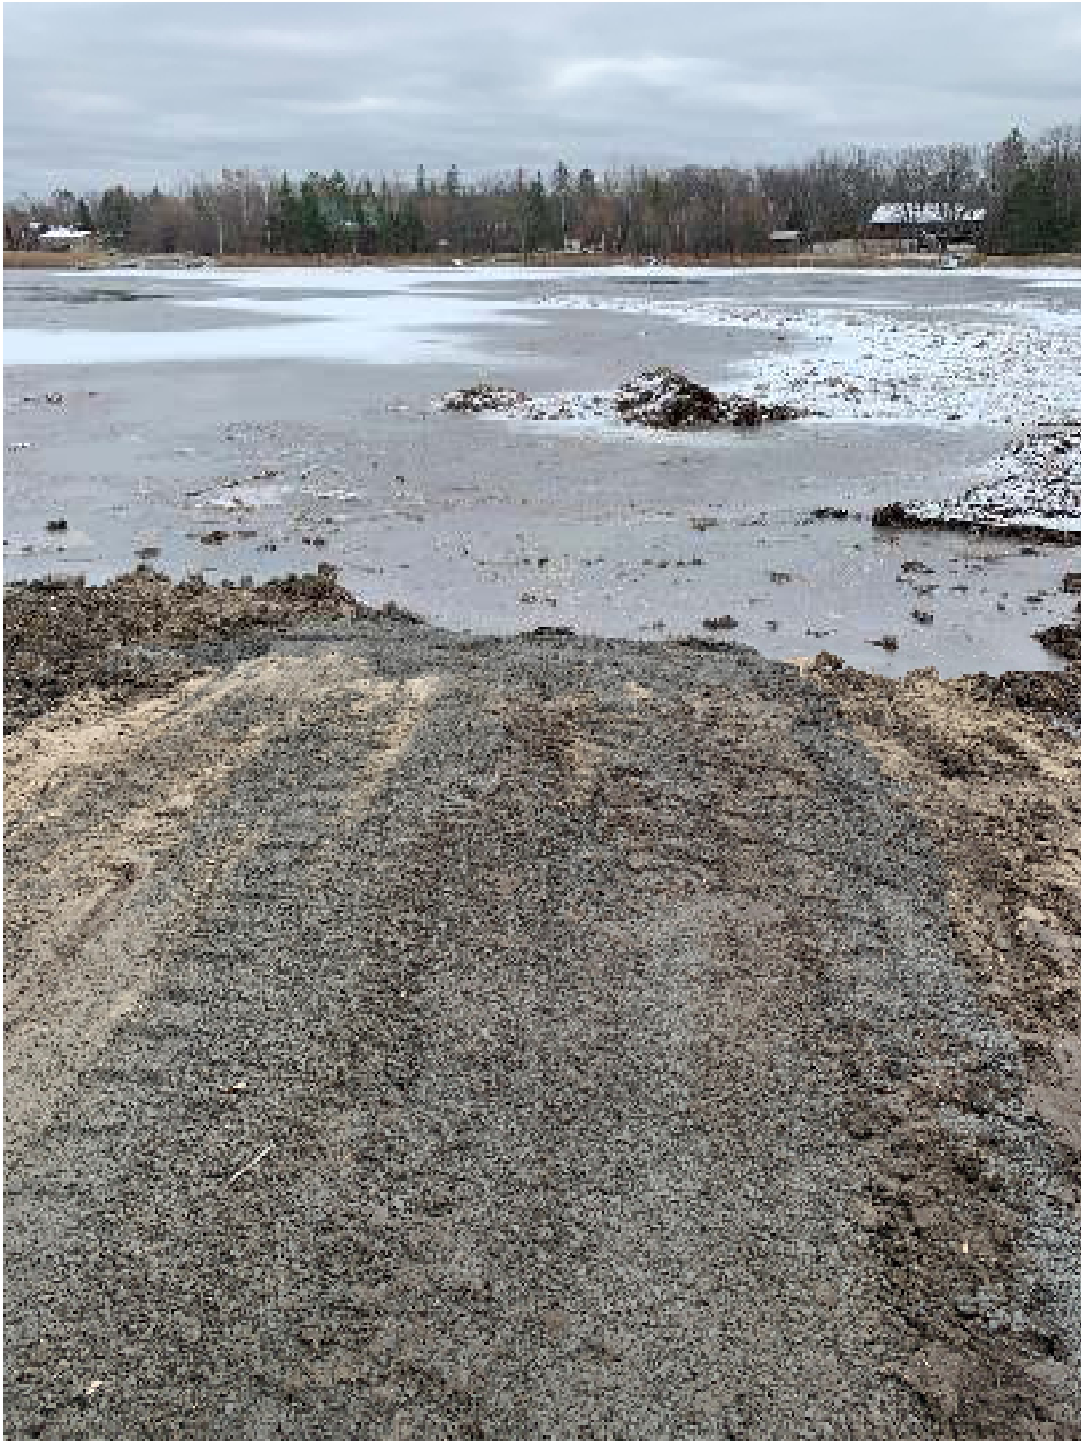
Figure 25 Resurfaced public access. Photo taken 11/2/2023
